## First Quarter, 1997

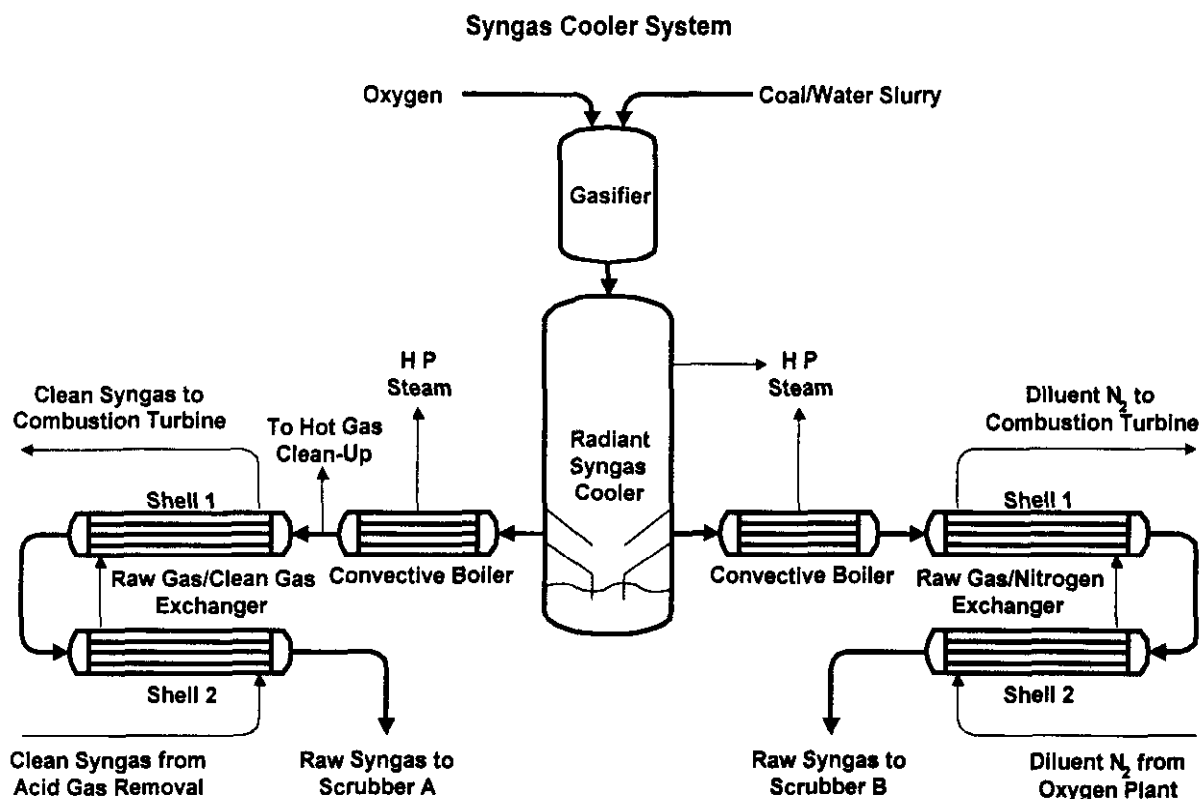
The Radiant Syngas Cooler and Convective Boilers continued to perform very well during the quarter. Fouling factors are less than half of design levels.

A serious failure of the second stage raw gas / clean gas heat exchanger occurred during Run 25 between March 14 to March 16. The higher pressure, ash laden raw syngas leaked through a ruptured tube into the lower pressure clean syngas en route to the combustion turbine. The ash melted in the turbine's combustor and deposited on various turbine components (see the Power Block Section). The tube failure was determined to have been caused by stress corrosion cracking, most likely initiated by earlier ash plugging problems in these exchangers. The following repairs were made to try to avert similar incidents in the future:

- 1) The second stage of the Raw Gas/Clean Gas Exchanger was removed from service. Eddy current testing had shown the tubes in this shell to be in the worst condition of the four gas to gas exchanger shells.
- 2) All tubes with corrosion pit depths to greater than 40% of the tube wall thickness were either replaced or plugged. This involved 31 tubes.
- 3) Bypass valves were added so that clean gas could be bypassed around the gas to gas heat exchangers to avoid another long outage in the event of a future heat exchanger tube leak.
- 4) Improved leak detection procedures were implemented to ensure that any future leaks will be detected at low levels. With this information, steps can be taken to transfer the combustion turbine off syngas fuel before damage to the combustion turbine occurs.

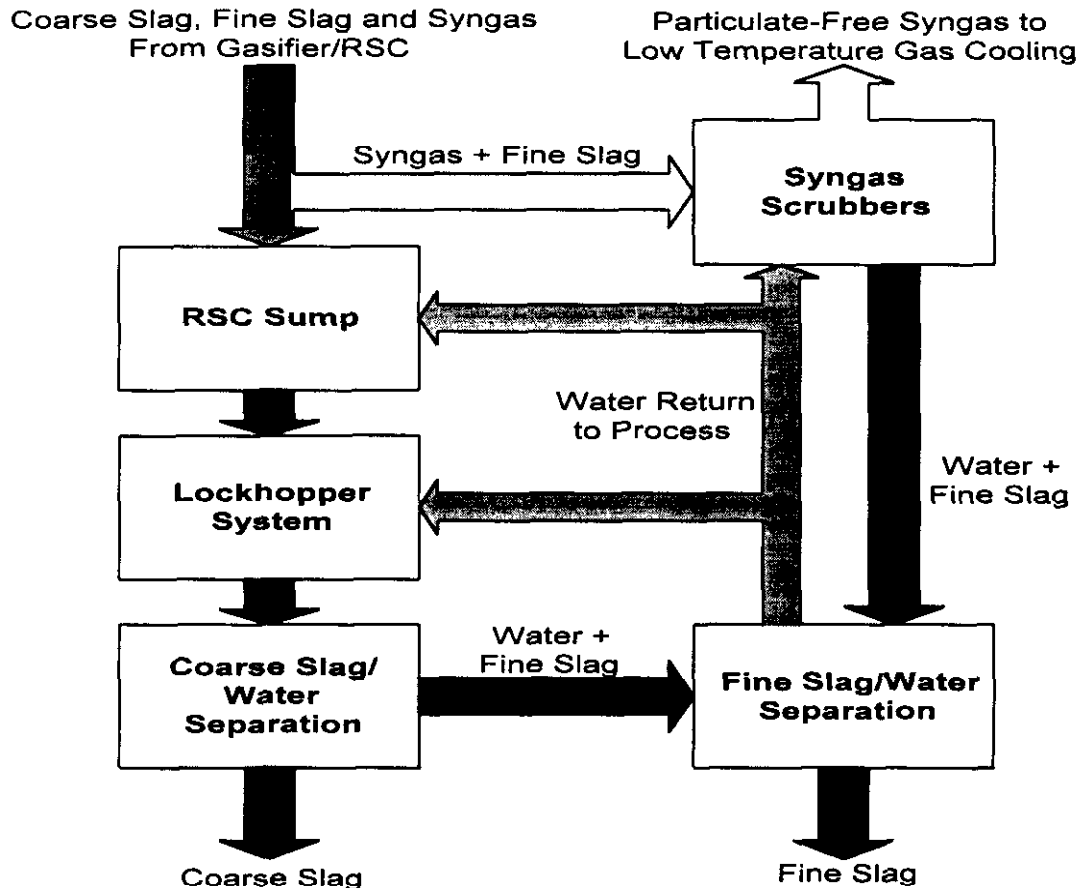
The slag handling system continues to be labor intensive. Run 23 was terminated due to overwhelming fines problems and the fines removal system is marginal under all operating conditions. Data is being gathered to support various redesign concepts in these areas.

Runs 22 and 24 were terminated due to leaks resulting from localized erosion in black and grey water piping, respectively. As such problems are identified, the local piping is redesigned, and these specific areas are added to the already extensive UT surveillance program.
